Water ingress to the caliper's sensor will cause irregular readings on the dash and/or sensor testing unit. This can also cause corrosion and prevent the caliper from functioning properly. When replacing the brake caliper, inspect the vehicle's sensor connector for signs of a damaged o-ring.

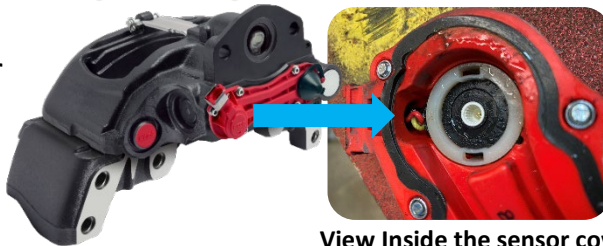
View Inside the sensor cover

A few drops of water within the caliper can cause faulty sensor readings and form rust on the internal components.

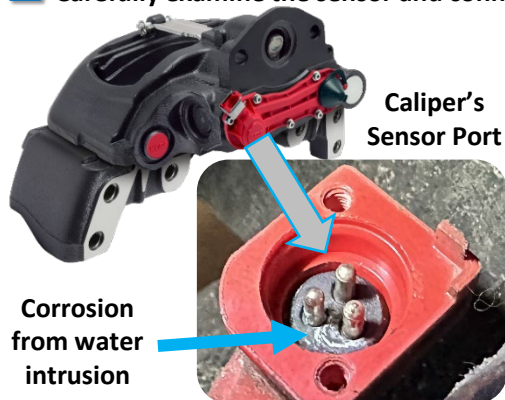
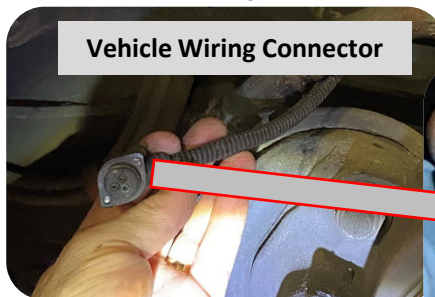
- The most common water entrance point to an ADB caliper's sensor is the vehicle's wiring connector o-ring. Carefully examine the sensor and connector for corrosion or signs of moisture.

Corrosion behind sensor cover from water intrusion

- Inspect the o-ring installed on the vehicle's wiring connector for damage when installing a new caliper. Replace the o-ring if any damage is found

If a sensor connector leak has been identified and water has entered the sensor cover, replace the ADB Caliper.
