Common Warranty Claims

The most common warranty claims for brake drums are:

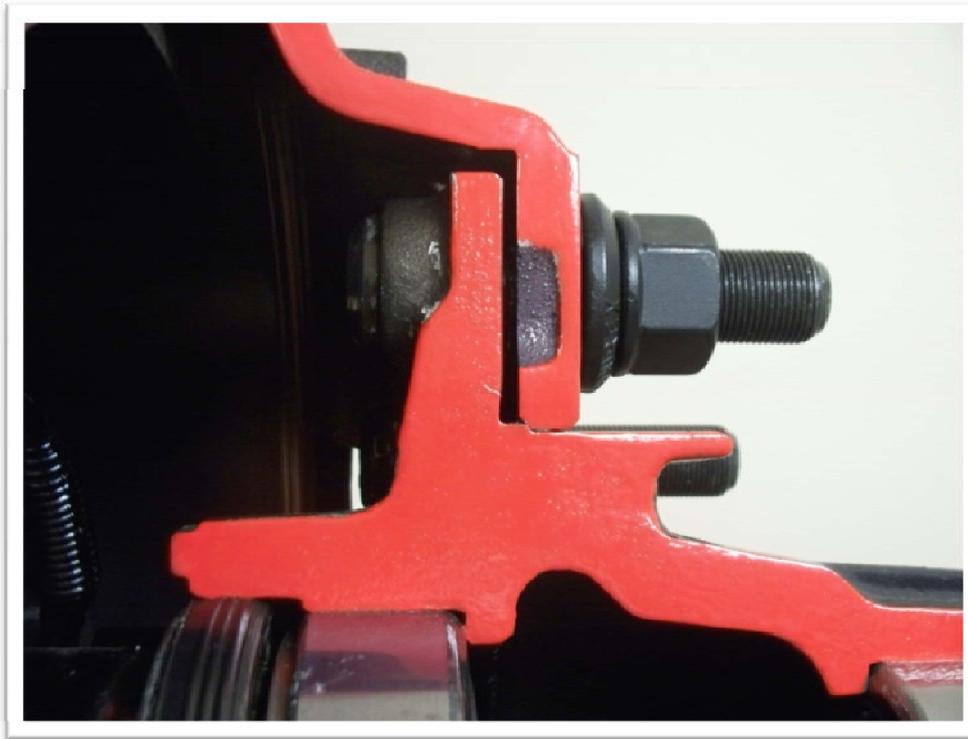
Improper Mounting – Inspecting the Pilot

- The drum's pilot hole is the feature that centers the drum onto the hub. This is true for inboard, outboard, ball-seat, and hub-piloted applications. All hub's, both spoke wheel and disc, have a receiving pilot. During assembly, if the drum is allowed to slip off of the hub's pilot and the assembly is tightened, the drum will push down on the hub's pilot causing an indentation.

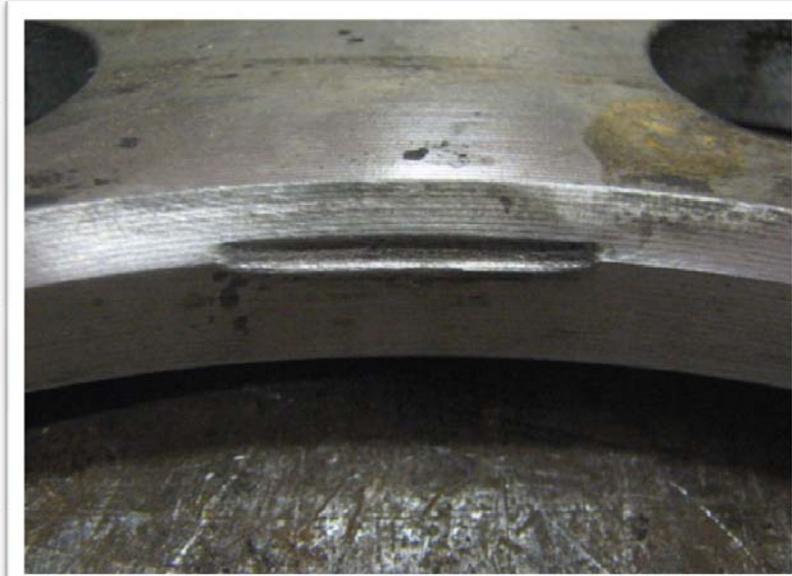
- Indentations can be very pronounced or barely visible. As a rule, if the metal has been deformed to any degree, the drum was improperly mounted.

Large indentation

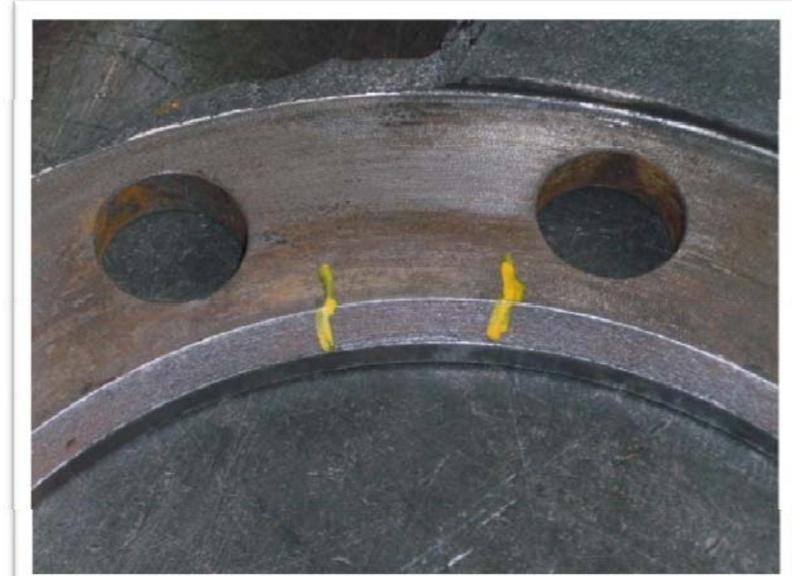
Small Indentation

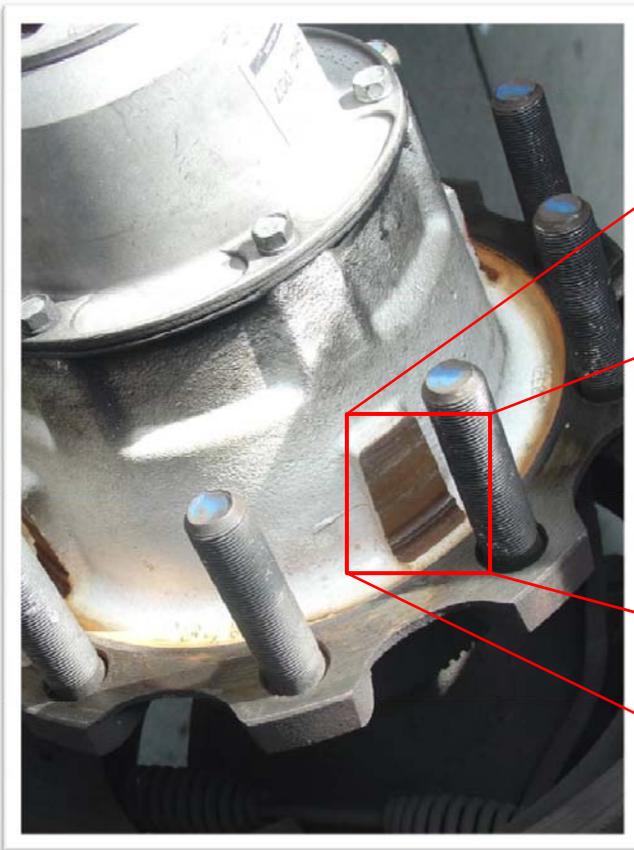
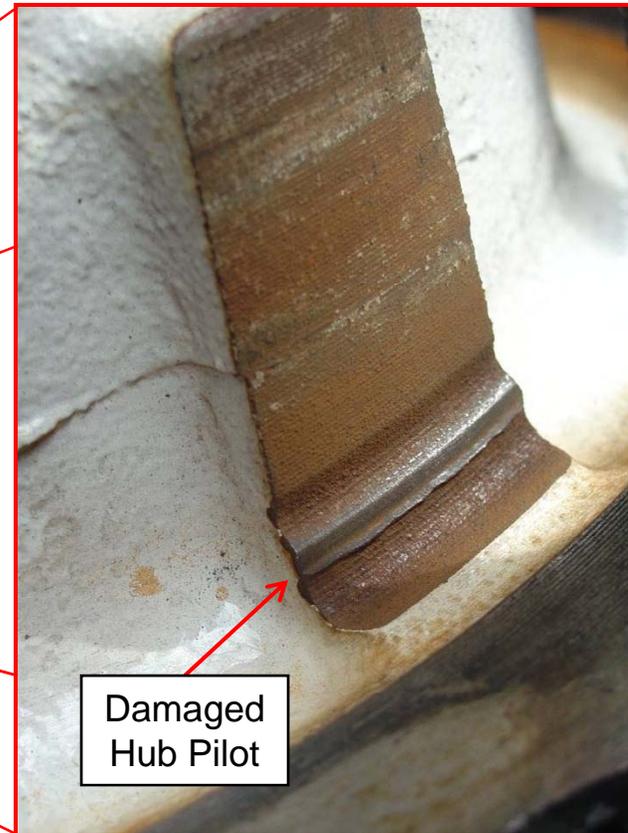
- Improperly mounting a brake drum onto a hub also affects the hub's pilot as seen below. This damage would prevent future drums from piloting correctly and could lead to "out of round" complaints for a drum with no quality or workmanship defects. The drum may also not show any indentations in the pilot.

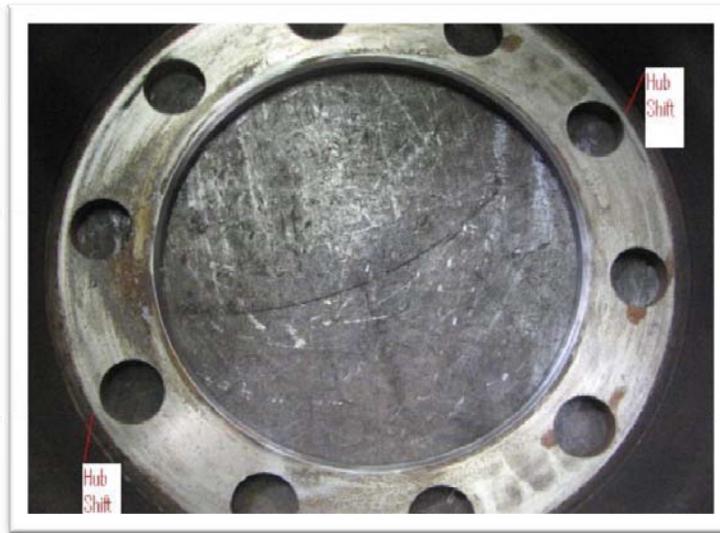
- Over time, brake dust and debris will build up on the drum's inside mounting surface around the hub's mounting flange, leaving the imprint of the hub's mounting surface. By looking at the distance between the imprint and bolt holes, you may see that the hub imprint is eccentric with the bolt holes.

**Notice the difference in spacing between the two bolt holes and hub imprint below.*

- If the drum was mis-mounted and an offset hub imprint was found, the braking surface should reveal localized heat checking, discoloration, and/or wear in the area where the bolt hole/imprint spacing is the largest ... confirming a mis-mount.

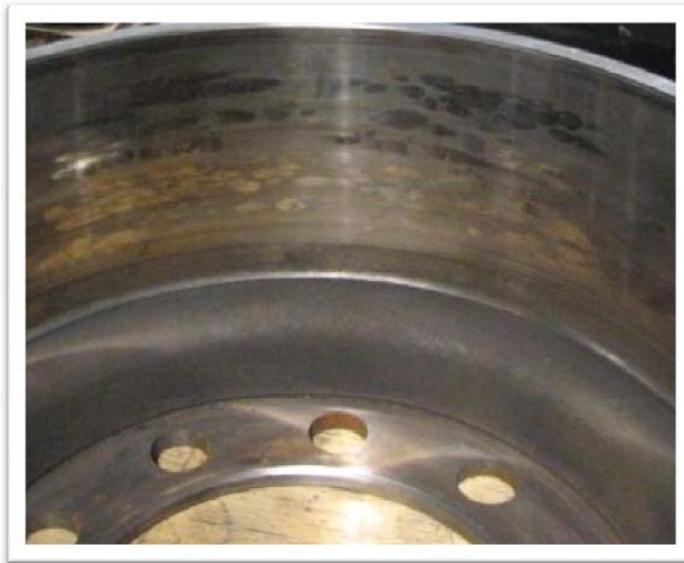
Improper Mounting - Braking Surface

- The braking surface of the drum is an indicator whether the drum was or wasn't properly centered.
- If the braking surface displays even wear, even heat checking (if present), and even blue spots or discoloration, it is doubtful that the drum was improperly mounted.
- If the braking surface wear is uneven and/or heat checking is localized and/or blue spotting is localized, the drum and brakes were not concentric. This means the drum was improperly mounted or it could mean the drum may have been machined incorrectly.
- The only way to verify if the drum was machined incorrectly is to have it returned for full inspection.

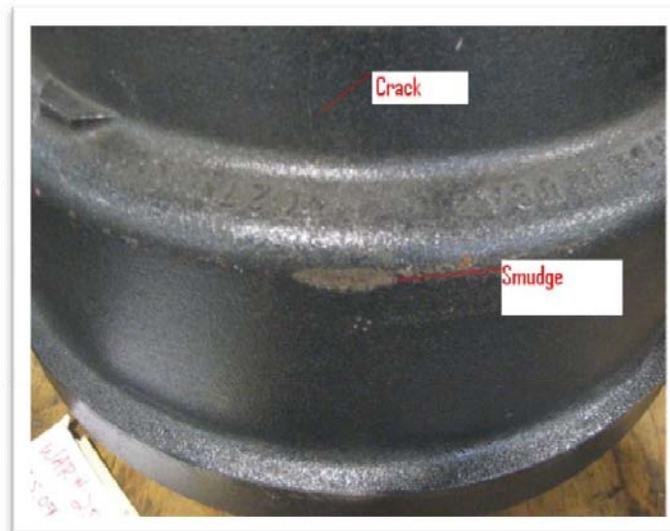
Between Pilot and Bolt Holes

- Brake drums with cracks between the pilot and bolt holes are generally caused by:
 - Improper handling (drum was dropped or impacted with a hard object)
 - The mounting surfaces of the drum and hub were not assembled flush with one another.
- If a crack is caused by the brake drum being dropped, a smudge can generally be located on the OD of the drum as seen below. This smudge generally aligns with the crack.
 - It is Webb policy that if a brake drum were to be dropped, it is immediately taken to the QA department for full inspection.

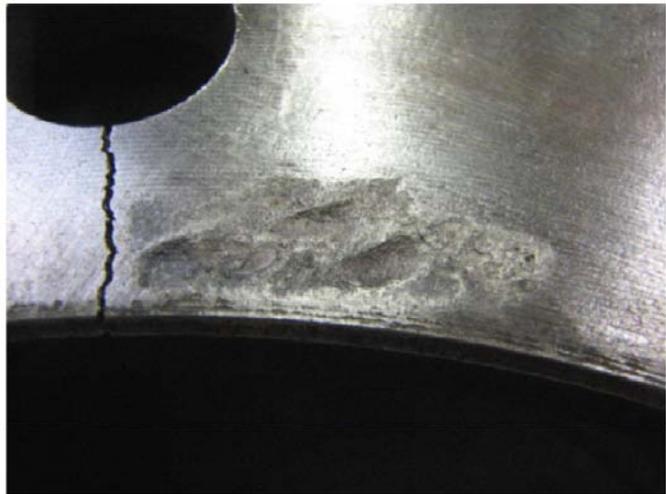
- If the mounting surface is struck with a hard object, this can also cause a crack.
- If the hub and drum's mounting surfaces are not flush during assembly, tightening of the assembly can cause the flange to stress and crack.

Impacted Drum

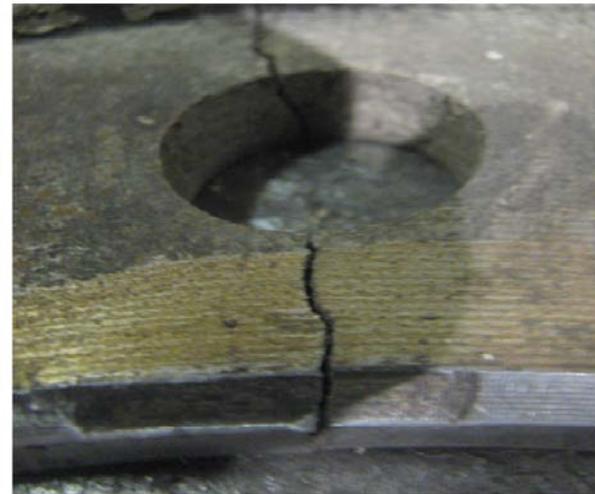
- Debris/dirt/corrosion in the hub's pilot radius
- Debris or foreign material trapped between the two surfaces during assembly.
- The drum was mounted on an incorrect hub (i.e. hub's pilot much larger than the drum's)
- Improper mounting.

Installed on Incorrect Hub

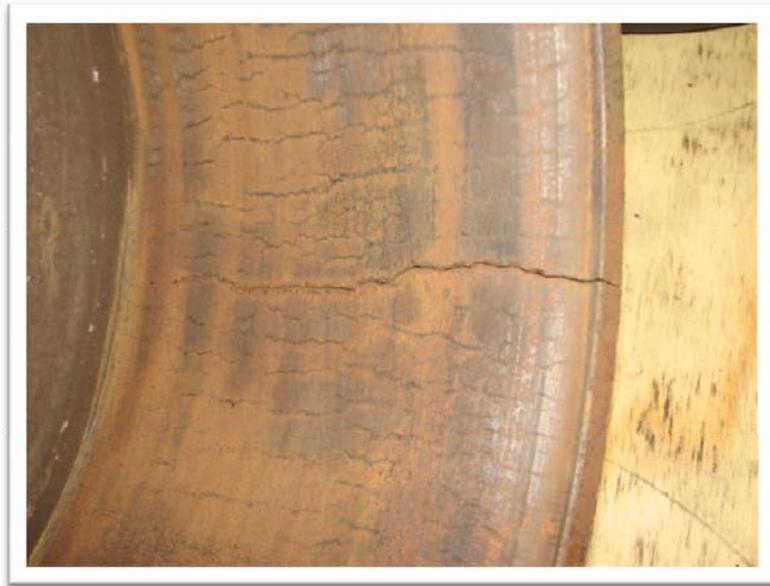
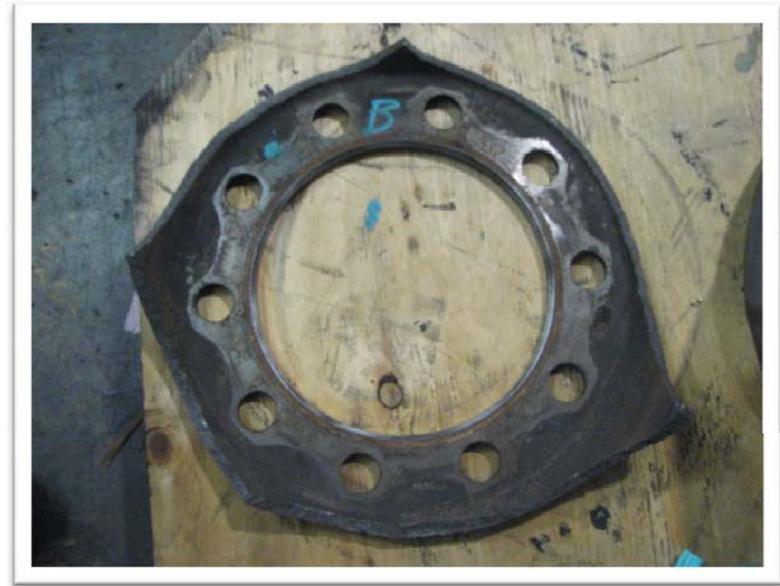
- Cracks on the braking surface are typically caused by heat checks forming on the braking surface and coalescing together. Cracks can also be caused by:
 - Being dropped
 - Parking brake engaged while drum is hot and thermally expanded
- A crack on braking surface can propagate to the bottom of the plunge cut and will typically do 1 of 2 things:
 - Wrap 360 degrees around the drum, separating the braking surface from the flange and wrap around.
 - Propagate straight through the wrap around and wrap 360 degrees around the flange, separating the braking surface and wrap around from the mounting flange.

Braking Surface - Continued

- If a brake drum is mis-mounted, brake shoes only contact a portion of the braking surface. If not caught in time, a crack can form in the offset region of the braking surface.
