A few drops of water within the caliper can cause corrosion and lead to caliper failure.

Water ingress to the ADB caliper will cause corrosion and prevent the caliper from functioning properly. When performing brake maintenance, look for signs of water intrusion and rusting within the caliper and brake chamber.

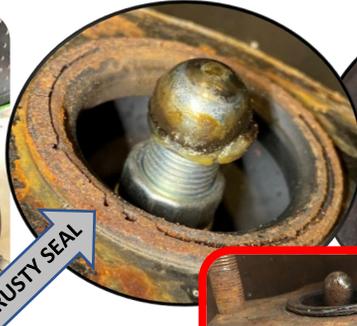
RUSTY SEAL

Damaged seals within an air chamber can allow moisture to enter the brake caliper.

Check the age and condition of the air chamber. A new caliper will not resolve issues

caused by a failing air chamber. The air chamber's internal seals can fail, thus causing contaminants to enter the air chamber and caliper. If the air chamber's condition cannot be verified or is questionable, replace the air chamber when the ADB caliper is replaced.

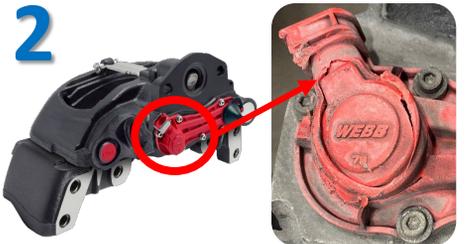
Contamination Entrance Point

Improper chamber installation can allow contaminants to enter the caliper

The air chamber's face seal prevents contaminants from entering the caliper. Ensure this seal is not damaged and protrudes at least .12" from the chamber housing.

Tighten the air chamber's installation nuts in an alternating sequence so the chamber mates flush to the caliper.

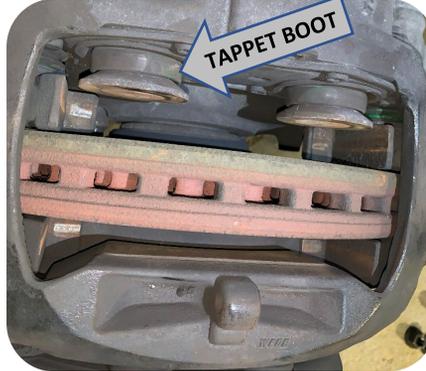
TAPPET BOOT

Inspect tappet boots for tears or heat damage that could allow moisture to enter the brake caliper and replace as required.
